PELVIC REPAIR SYSTEM PRODUCTS

Master File No. 2:12-MD-02327 MDL 2327

Intentional Oxidation of Prolene Mesh Supplemental Report of Dr. Shelby F. Thames August 8, 2016

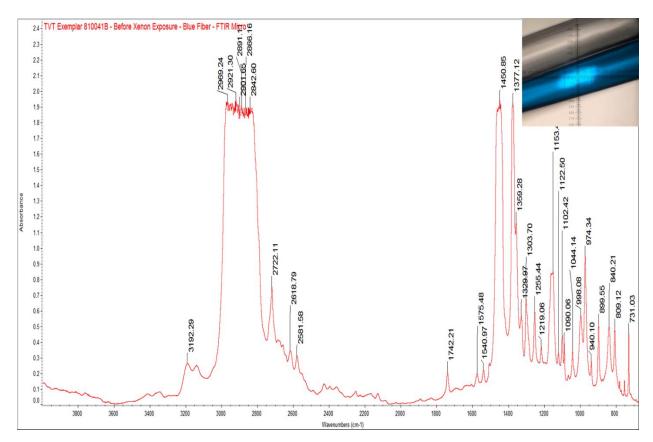
The pristine exemplar TVT sample was characterized via Fourier Transform Infrared Microscopy (FTIR) with a Thermo-Nicolet Continuum FTIR Microscope (Figure 5) prior to UV exposure. The resulting spectrum (Figure 6) contains an inset image showing the penetrating IR beam location. The absorption frequency at 1742 cm⁻¹, indicative of Ethicon's DLTDP antioxidant, is also noted in my previous reports, which I rely upon, and is present in the spectrum.

Figure 6. Pristine TVT Exemplar 810041B - Before Xenon Exposure - Blue Fiber

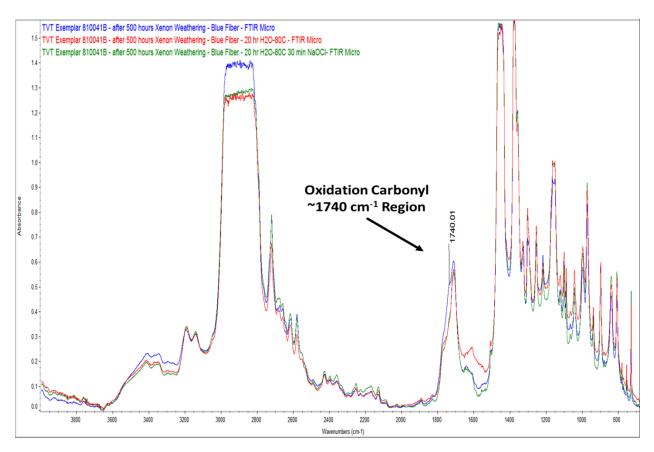
The oxidized TVT exemplar (Figure 7) was immersed in 80°C water for 20 hours, removed, dried, and analyzed via FTIR microscopy (Figure 8 – red Spectrum). The oxidized TVT exemplar was then immersed in sodium hypochlorite solution (NaOCI) on a shaker for 30 minutes, removed, dried, and again analyzed via FTIR microscopy (green spectrum). Although there was no flesh present to utilize sodium hypochlorite's oxidizing capacity, the FTIR spectral overlay demonstrates that carbonyl (oxidation) absorption did not diminish during, and as a result of, the cleaning protocol (Figure 8). Thus, it is abundantly clear that should carbonyl oxidation of Prolene occur, the resulting carbonyl frequency, as shown herein, would be present in the FTIR spectrum of the oxidized Prolene sample.

To date, the cleaning protocol of Figure 1 did not remove oxidized carbonyl moieties from Prolene. Moreover, should oxidized Prolene be present it will be seen as a strong carbonyl frequency at or near ~1740 cm⁻¹.

Figure 8. Overlay of Blue Fiber TVT Exemplar 810041B – After 500 hrs. Xenon Exposure (Blue Spectrum), After 20 hrs. Immersion in 80°C water (Red Spectrum), and After 30 min. Immersion in NaOCI (Green Spectrum)

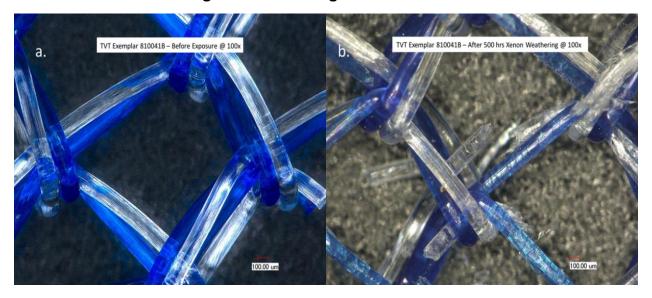
Digital microscopy and scanning electron microscopy (SEM) of the before and after fiber exposure samples were conducted with a Keyence VHX-600 digital microscope (Figure 9) and a Zeiss Sigma VP FEG-SEM (Figure 10). One can readily observe the oxidation effects upon Prolene as demonstrated by light microscopy and SEM images (Figures 11 and 12) of fibers; before and after UV exposure. As a result of UV exposure as described herein, Prolene fibers were grossly embrittled and demonstrated deep cracks resulting in fiber rupture via crack propagation.

Note the extensive fiber cracking and flaking: the product of crack propagation. Clearly the physical properties of Prolene have been severely compromised by UV light exposure (i.e. oxidative degradation).

Figure 11. Light Microscopy of TVT 810041B Exemplar before UV exposure (a.) and after 500 hrs. UV exposure (b.)

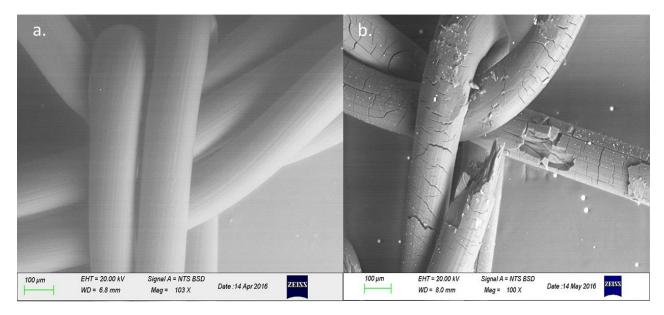
Figure 12. SEM of TVT 810041B Exemplar before UV exposure (a.) and after 500 hrs. UV exposure (b.)
